Submission to the Port Geographe Technical Working Group

**Port Geographe Land Owners Association
5 February 2020**

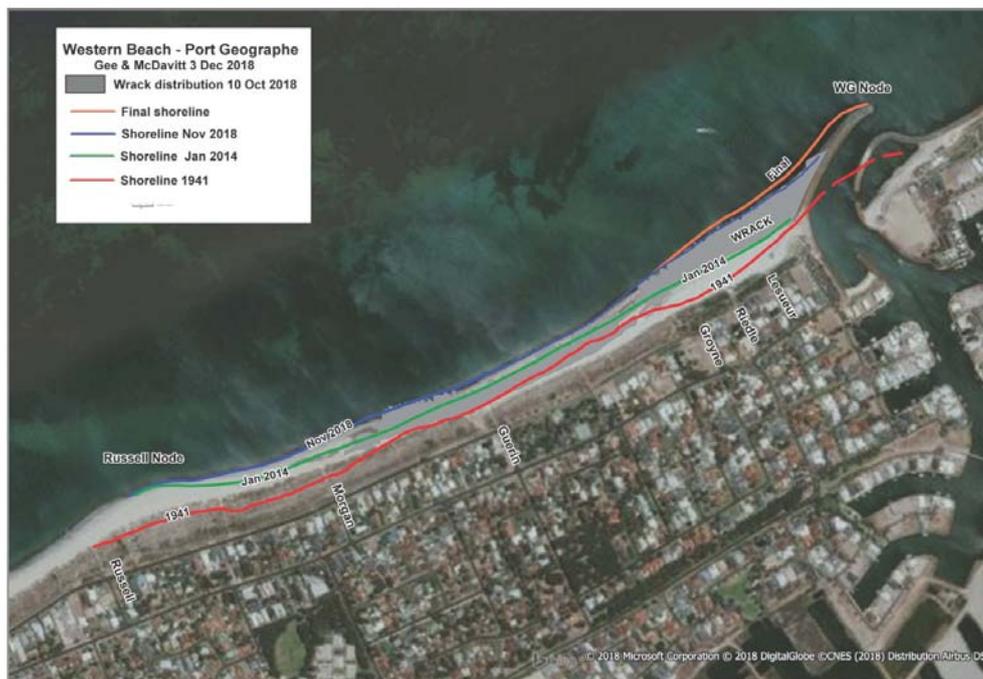
Figure 1: Western Beach between Russell Node and Western Breakwater showing historic shorelines and 2018 wrack

6. The ideal beach shape will be a gentle embayment between the tip of Western Breakwater and Russell Street Node; its shape will mimic that of previous nodes and embayment going back to 1941, but will be displaced seaward, not laterally.

Point 6 above is particularly relevant to Western Beach. It will always be a gentle embayment that will attract wrack accumulations, as it has done for decades prior to the initial development of Port Geographe. In terms of wrack management, there is no point in filling the embayment with sand to form a straight line between the Russell St and Western Breakwater nodes. It will naturally revert to a gentle embayment, because the shape of Western Beach is controlled by proximity to near-shore oblique sandbars.
